# PIC18F26/46/56Q71 Silicon Errata and Data Sheet Clarifications

## PIC18F26/46/56Q71

The PIC18F26/46/56Q71 devices that you have received conform functionally to the current device data sheet (DS40002329F), except for the anomalies described in this document.

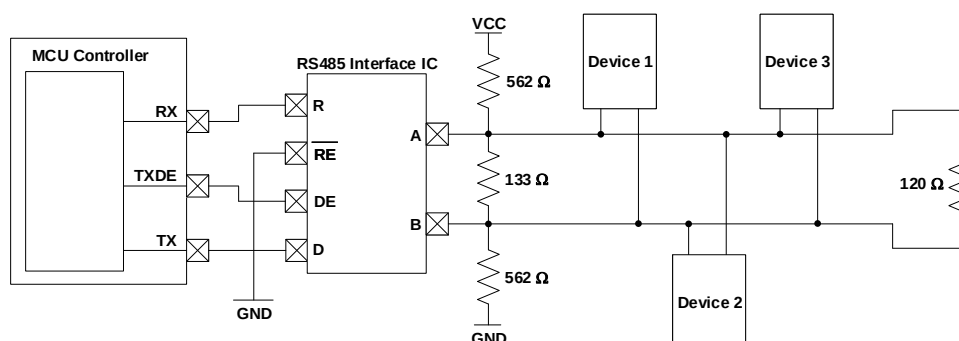
### 1.4.1 UART TXDE Signal May Go Low before the STOP Bit Has Been Entirely Transmitted

The UART Transmit Drive Enable (TXDE) signal could potentially transition into a low state before the UART STOP bit has been entirely transmitted due to the effects of parasitic capacitance on the TX line. In some applications, this could result in communication being prematurely terminated due to the TXDE bit going low before the STOP bit has had enough time to settle.

To ensure that the STOP bit settles into its final logic state before the TXDE signal transitions low, a biasing circuit can be implemented. A biasing circuit allows the TX line to either be driven high or low, rather than being left in a floating tri-state mode where prolonged rise or fall times could lead to communication being disrupted. This bias circuit should only be implemented on one end of the serial bus, and a termination resistor should be used on the other end. The figure below shows an example of a bias circuit that can be used to achieve this.

Please note that the resistor values used in this circuit are recommendations and that the actual resistor values required may vary based on the application.
